12th CIRP Conference on Photonic Technologies [LANE 2022], 4-8 September 2022, Fürth, Germany

# A deep learning approach for real time process monitoring and curling defect detection in selective laser sintering by infrared thermography and convolutional neural networks

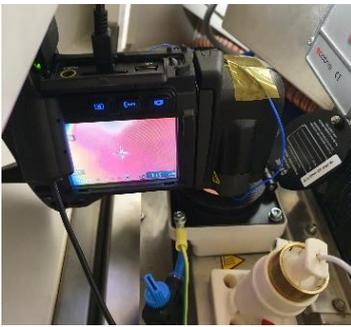
Fig. 1. FLIR camera setup

The experimental setup was applied on the EOS Formiga P110 SLS machine for polyamide powders (PA12 was used in this case). A FLIR T420 thermal infrared camera was installed at the top window of the machine to record the temperature distribution at the surface of the powder bed. The camera system has 320 x 240 pixels and 30 frames per second. As seen on Fig. 1 and 2, a calcium fluoride optical window was used to separate the camera system from the actual installation space. Calcium fluoride has a very low refraction index of 1,434 (no anti reflection is necessary) and a transmittance of more than 90% at the spectral range. First test runs revealed a slightly coating at the optical window, caused by vaporization during the sinter process. This indicates that installed nitrogen flushing had to be revised in further iterations [5].

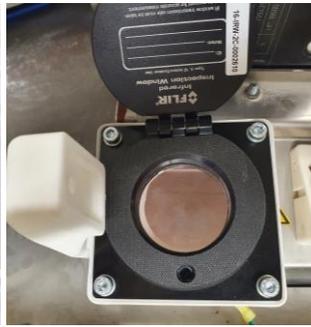
Fig. 2. Calcium fluoride window

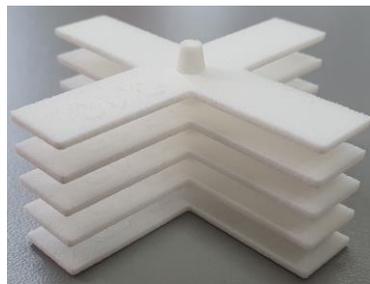
Fig. 4. Calibration part

Standard calibration parts were used throughout the whole project. These parts contain five stacked cross sections by the

dimensions of 50 mm x 50 mm as seen on Fig. 4. The cross sections are connected by conical structures with a total height of 14,5 mm. The components are usually used to verify default parameters of the sintering process. The temperature settings of each of the four powder bed sections are calibrated manually. Therefore, the distance between the cross sections of the calibration parts are evaluated to detect any deviations like curling.

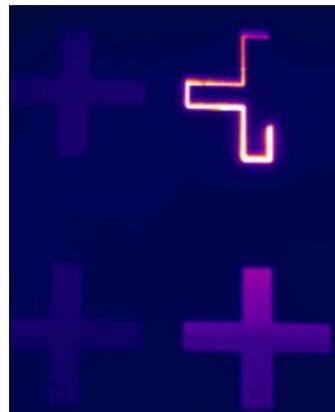
Fig. 5. Outline laser exposure

Fig. 5 shows the outline laser exposure of the test parts. As seen on Fig. 6, there is a significant temperature difference between the powder bed and the literal part after laser exposure. Towards the next applied layer and cooling time, the temperature distribution at the powder bed surface was nearly homogenously.

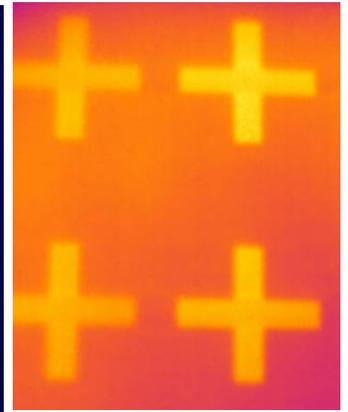
Fig. 6. Layer cooling down

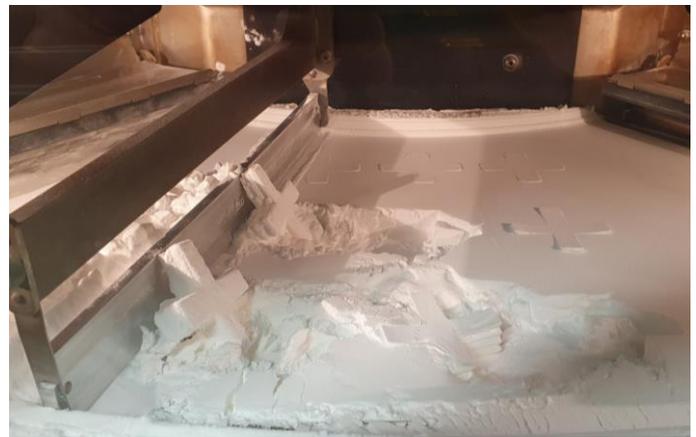
Fig. 7. Increasing curling and movement of the coater led to total process abortion

The experimental trials were continued until total process abortion to show maximum possible impact of failures. By increasing curling effect and applying a new layer of powder, the coater ripped out some parts of the powder bed and got stuck as seen on Fig. 7. In cases like this, a complete restart of the process is required. All parts at the surface are defective and have to be removed including non-used polyamide powder. Beside increasing cost factor, a massive delay will result due to cleaning and pre-heating the machine.

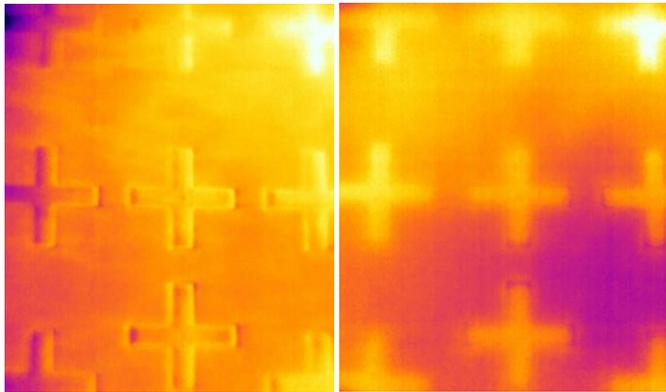
Fig. 8. Visible curling after coating

Fig. 9. Visible curling after layer cooling time

The frames of the thermal recordings were extracted, compared and evaluated to get first impressions about the depiction of curling. Due to the high amount of data (>140.000 frames per process where rendered), samples were used every 1000 frames. First considerations revealed the expected results: even immediately after coating of a new layer of polyamide, the effects of curling appears clearly at the thermal images as shown on Fig.8. Towards the layer cooling time, the effects where still verifiable as shown on Fig. 9. They appear only in certain spots, also shown on Fig. 9, due to an uneven temperature distribution, caused by manually adjusting the process temperature.

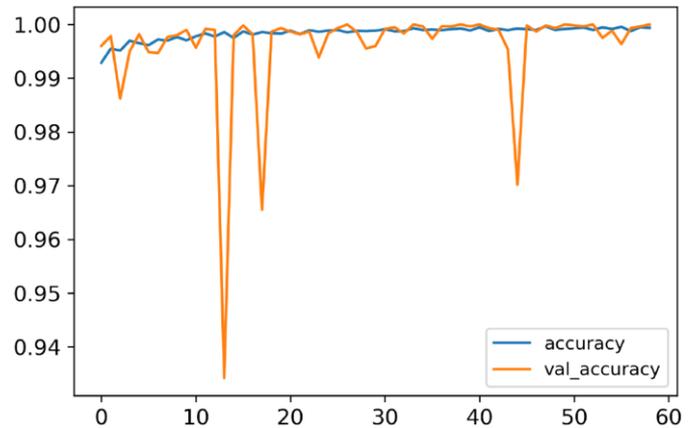
Fig. 10. Accuracy behavior during the training epochs on train and validation data [8]

VGG-16 network was iterative trained using the following hyperparameters: binary cross-entropy cost function, 10<sup>-3</sup> learning rate, Adam optimizer ( $\beta_1=0.9$ ,  $\beta_2=0.999$ ), 100 epochs and early stopping with patience=20. The network performed quiet good during training as seen on Fig. 10. The training stopped after 59 epochs revealing an remarkable accuracy of 99,1 % and F1 score of 97,2 % as seen in Table 1 [8].

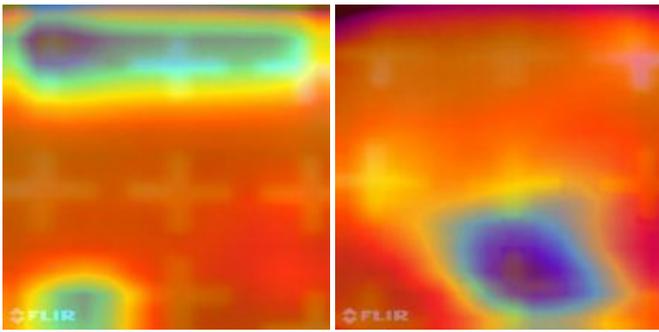
Fig. 11. Grad-CAM heat map correct process

Fig. 12. Grad-CAM heat map defective process

A clear difference is visible between the heat maps of correct and defective processes as shown on Fig. 11 and 12. There were no significant variations of the heat maps during the correct process (see Figure 11), but in the case of the defective process, the heat map revealed distinct changes as seen on Figure 12. This corresponds to thermal images of the defect process (see Figure 7), the more the failure occurred, the more the “hot spot” moved to the centre of curling as seen on Figure 12 (right bottom corner).
